Use of Deep Foundations for Hurricane Damage Repair

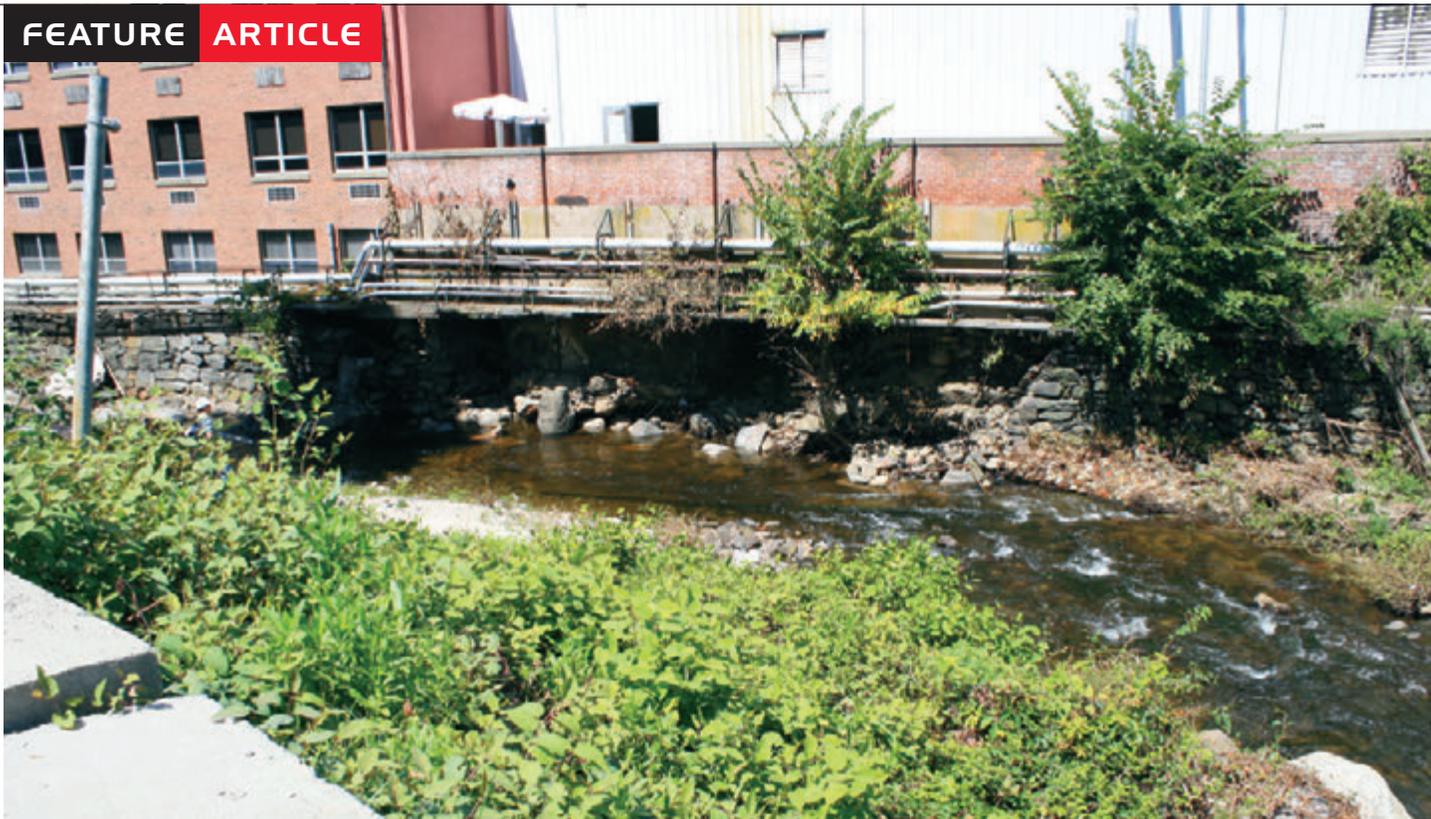
Collapsed wall after August 14-15, 2011 storm

During the storm, approximately 75 linear ft (23 m) of wall collapsed due to river scour. Subsequent erosion removed approximately 25 cu yds (19 cu m) of material behind the wall, exposing and partially undermining foundations for both buildings. The collapsed wall debris was found deposited some 750 ft (229 m) downstream.

GEI was hired by Kerite to design and coordinate site repairs. The first task was to temporarily stabilize the river banks and protect structures prior to the arrival of Hurricane Irene, which was rapidly approaching the area. GEI developed a scheme to place 450 tons (408,233 kg) of

individually-packed riprap and boulders within the area. When the hurricane eye passed about 25 mi (40.2 km) west of the site on August 27-28, the riprap and boulders, largely submerged during the hurricane, successfully redirected flow and protected the structures from further damage.

Input on selection was provided by state and federal permitting agencies, as well as from Kerite and its insurance agency. The selected alternative was a retaining wall in place of the collapsed one. However, the wall needed to be of robust construction to withstand the high water velocity and scour potential.

The design incorporated 24 micropiles spaced at 3 ft (0.9 m) on center. The tight spacing was intended to resist scour, in hopes that the dense soil matrix would provide a possible arching effect between the micropiles. The micropiles themselves consisted of 9.6 in (24.5 cm) diameter casing with 0.5 in (1.4 cm) thick walls, central

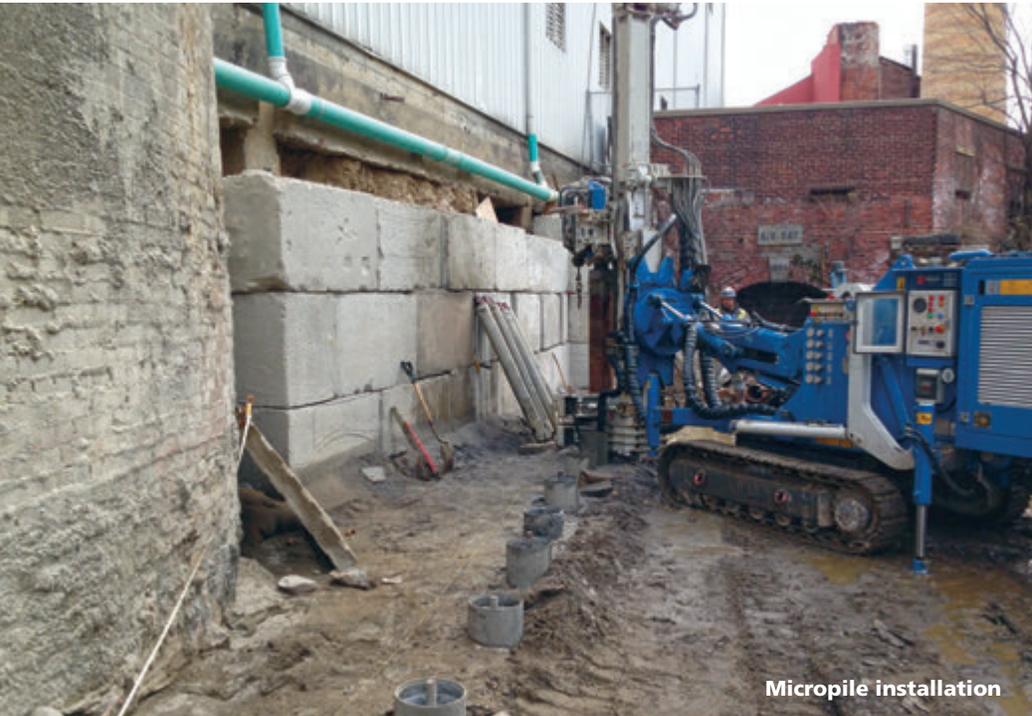
Retaining Wall Construction

An 18 ft (5.5 m) cast-in-place concrete retaining wall was chosen by the project team for the final wall type, designed with fairly non-typical proportions. The wall has a thick continuous-width 30 in (76 cm) stem to accommodate embedded micropiles, which protruded approximately 5 ft (1.5 m) above riverbed. The heel length was limited to 5 ft (1.5 m) to avoid existing structures behind the wall, and the toe length was limited to 2 ft (0.6 m) to minimize stream encroachment. The base of the wall could not be significantly embedded into the riverbed, since that would require underpinning nearby foundations.

The retaining wall design incorporated deep foundation elements. The project team chose vertical micropiles for a variety of reasons, particularly for supplementing the capacity of the oddly-proportioned wall, ease of drilling through dense glacial till and minimal disturbance to nearby structures.

To provide additional lateral capacity, the general contractor drilled the tiebacks approximately 7 ft (2.1 m) above riverbed elevation. The tiebacks were spaced approximately 9 ft (2.7 m) horizontally, and had to be located carefully to avoid the foundation and other structures behind the wall. The tiebacks consisted of a grout-bonded multiple corrosion protection anchors with an 1.75 in (4.5 cm) all-thread bar and 4,000 psi (27.6 MPa) grout.

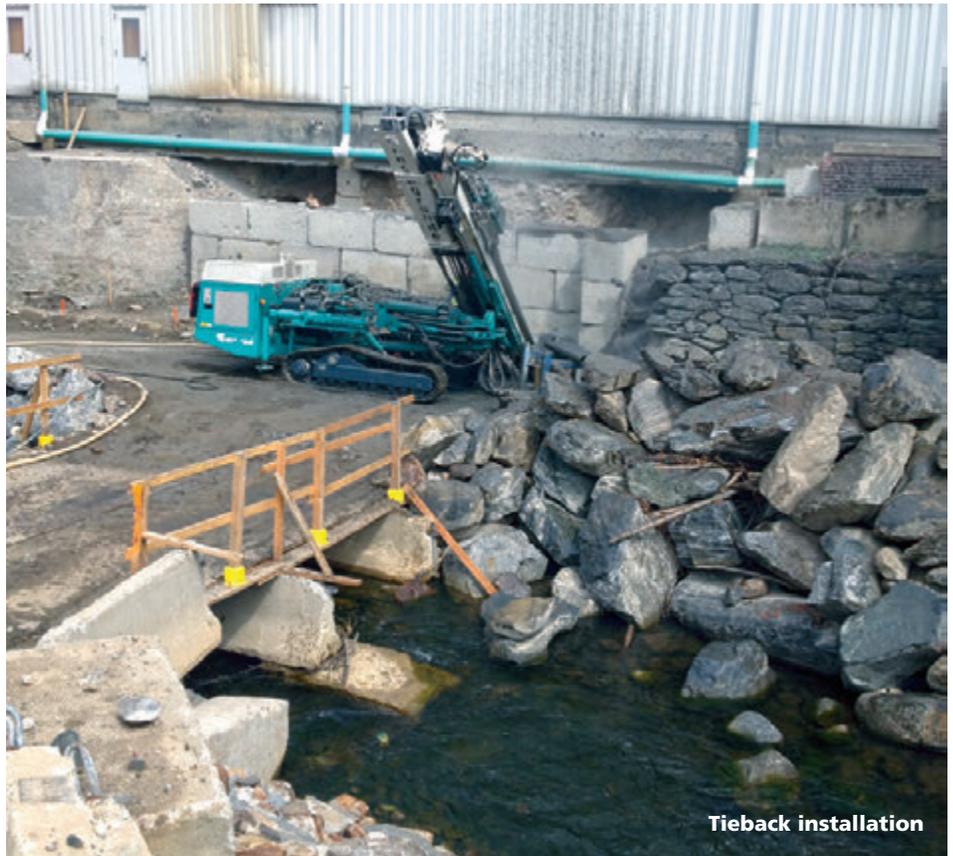
Tieback installation

After the retaining wall concrete was poured, workers installed tieback anchors after partial backfilling with select granular fill. The engineers performed proof tests three days after grout placement, and lock off loads were achieved at 120 kips (534 kN). The pockets for the tieback anchors were then capped with concrete.

We also established survey targets on the retaining wall prior to tieback installation and lock-off testing. Measurements showed approximately 1/16 in (0.16 cm) lateral movement at the top of the wall during lock-off testing.
